DEPARTMENT OF TRANSPORTATION

Contract #: 04-0120F4Cty: SF/ALA Rte: 80 PM: 13.2/13.9File #: 69.28**WELDING INSPECTION REPORT****Resident Engineer:**Siegenthaler, Peter**Address:** 333 Burma Road**City:** Oakland, CA 94607**Report No:** WIR-024007**Date Inspected:** 18-Apr-2011**Project Name:** SAS Superstructure**OSM Arrival Time:** 1500**Prime Contractor:** American Bridge/Fluor Enterprises, a JV**OSM Departure Time:** 300**Contractor:** Zhenhua Port Machinery Company, Ltd (ZPMC), Changxing Island **Location:** Shanghai, China**CWI Name:** Mr. Li Yan Hua**CWI Present:** Yes No**Inspected CWI report:** Yes No N/A**Rod Oven in Use:** Yes No N/A**Electrode to specification:** Yes No N/A**Weld Procedures Followed:** Yes No N/A**Qualified Welders:** Yes No N/A**Verified Joint Fit-up:** Yes No N/A**Approved Drawings:** Yes No N/A**Approved WPS:** Yes No N/A**Delayed / Cancelled:** Yes No N/A**Bridge No:** 34-0006**Component:** OBG**Summary of Items Observed:**

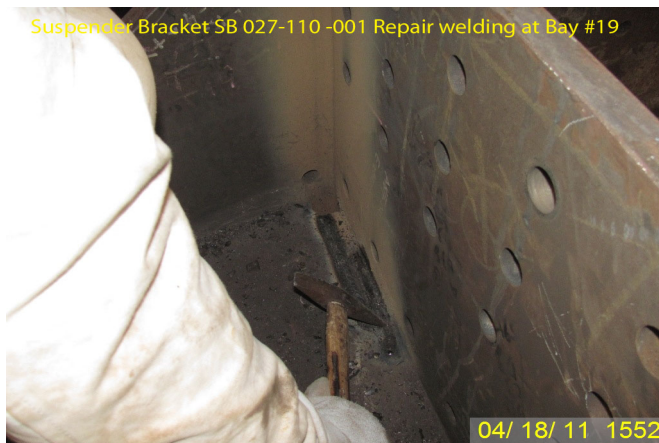
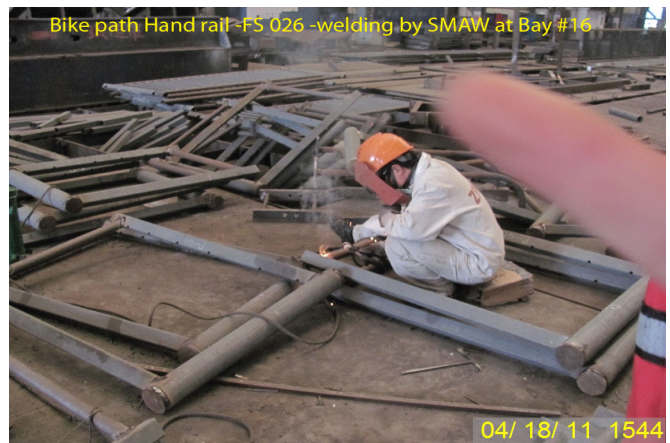
Repair welding of Weld joint- 001 as per CWR no. B-CWR-2929, Located on Suspender Bracket SB 027-110E. Welder is identified as 259566. ZPMC Quality Control Inspector (QC) is identified as Li Ping. The welding variables recorded by QC appeared to comply with the WPS-345-SMAW-1G (1F) –Repair.

Repair welding of Weld joint- X64A as per CWR no. B-CWR-2877, Located on Suspender Bracket SB 022-106W. Welder is identified as 202338. ZPMC Quality Control Inspector (QC) is identified as Li Ping. The welding variables recorded by QC appeared to comply with the WPS-345-SMAW-1G (1F) –Repair.
